**Town of Williamsburg
Building Needs Committee**
December 7, 2010

Town of Williamsburg Building Needs Committee:

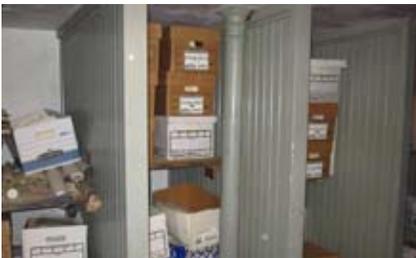
Records are stored in the basement despite evidence of moisture intrusion.

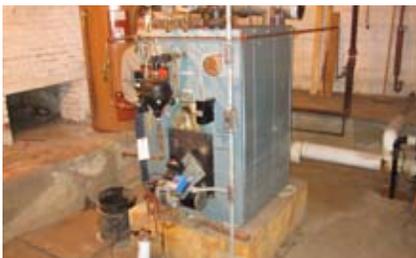
Steam boiler and water heater are old, in fair condition in spite of some updating. There are four older 275-gallon oil tanks in the basement, not in vaults, in aging condition made worse by dampness in the basement. Two sump pumps need vigilance to keep standing water out of the boiler room. Cooling is by window units of differing ages, and many windows don't operate for ventilation. Electrical service has been upgraded and is in very good condition: capacity is adequate. Most wiring is old and much-modified. Plumbing is minimal and outdated—there are often 20–30 people in the building with only two toilets. There are no sprinklers or security system, but a recent fire alarm system. Pipe asbestos has been remediated.

Steam boiler.

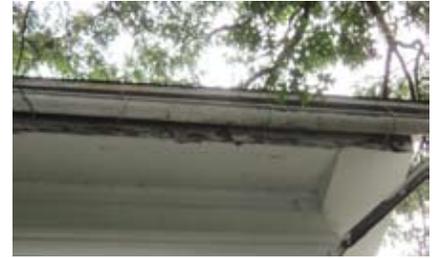
Soffits have significant rot. Gutters have also failed.

- ◆ Roof
- ◆ Gutters
- ◆ Chimney

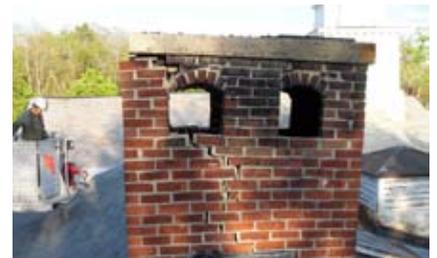
The chimney is badly cracked and in need of rebuilding.

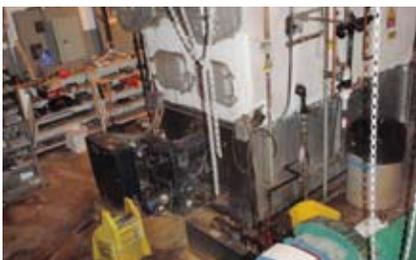
The boiler is well beyond its service life and could break down at any time.

- ◆ New Boiler
- ◆ Life Safety Improvements
- ◆ Replacement windows

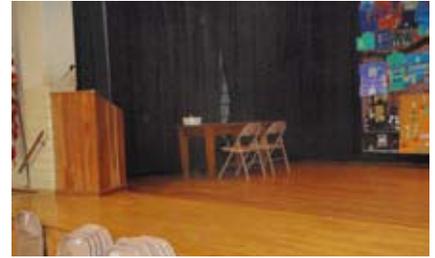
Original spaces have been converted to specialized use and are usually inadequate for the function. This photo shows a makeshift teaching space on the auditorium stage.

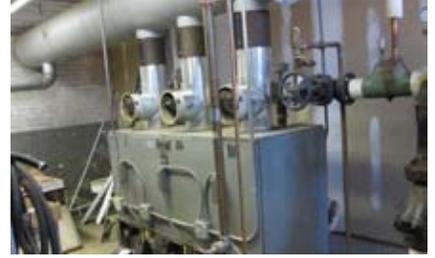
Boiler system, circa 1992.

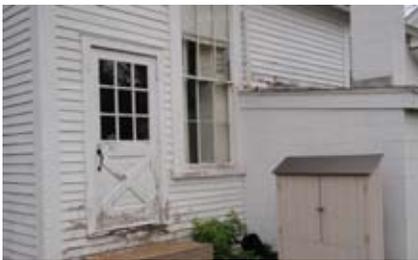
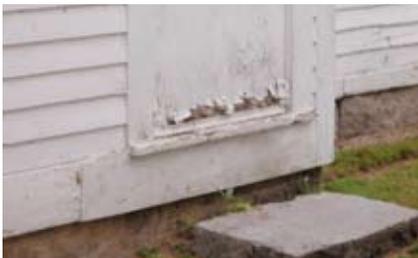
Moisture damage is widely apparent on the exterior.

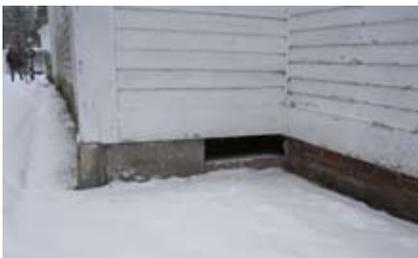
The fieldstone foundation has openings to the outdoors. It may be susceptible to movement by frost. Dirt floor in the crawlspace is allowing moisture to attack the floor structure.

The main roof is asphalt in good condition. Rear heating addition roof is ruined, including the structure. The rear addition has a brick foundation in poor condition. There are no gutters, so water gets to the foundation. Stone foundation is in poor condition in some parts, with cracks, tipped topstones, and weak rubble support. It appears the foundation does not reach below frost level, so is not stable. There is evident moisture intrusion into the dirt crawlspace. A missing rear stone allows animals into the crawl as well, which is reached by humans by a steep ladder from an awkward bathroom trap door. The main floor is supported by round joists about 30" on center, so is underbuilt by today's standards. There is some decay in the floor framing, which has been patched over the years. Above-grade floors are the original wood, tiled over with VCT in some places. Ceilings and most walls are in adequate condition, though undoubtedly painted with lead-based paint. The main room has a crude central dividing wall, and the stage is similarly divided from them; other partitions are more substantial. Clapboard siding is in decent condition, though exterior trim is shifted in some areas and needs some work. Exterior signage is adequate and lighting is minimal. The yard is small and grassed, with a memorial plaque in front.

- ◆ Foundation
- ◆ Roof/water infiltration
- ◆ Heat/furnace

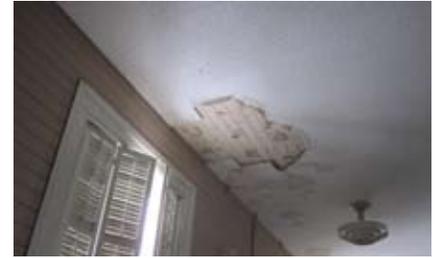
Though the main roof is in good condition, water is getting in around the cupola, resulting in damage to the building and the collection of the Historical Society housed inside.

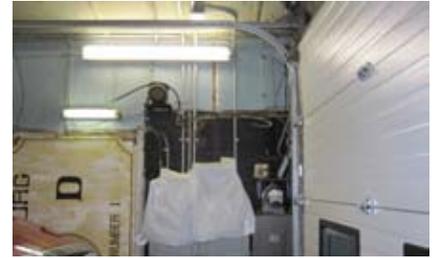
Electrical service is subject to water leaks.

- ♦ Fixing roof leaks and ongoing maintenance are all that are recommended to keep the building from deteriorating further.

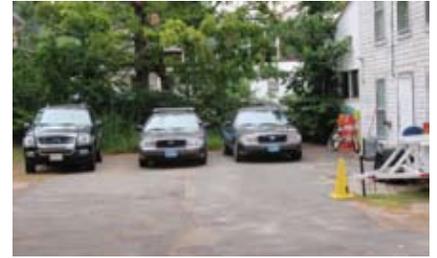
Parking in rear for three police vehicles.

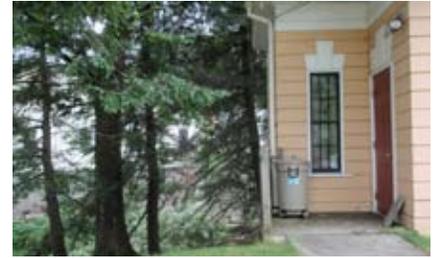
Back entrance.
