# **Feasibility Study for the Mill River Greenway at the Brassworks**

Town of Williamsburg, Mill River Greenway Brassworks Subcommittee

Town of Williamsburg  
Mill River Greenway Committee  
Brassworks Area Subcommittee

Dodson & Flinker, Inc.  
463 Main Street  
Ashfield, MA 01330

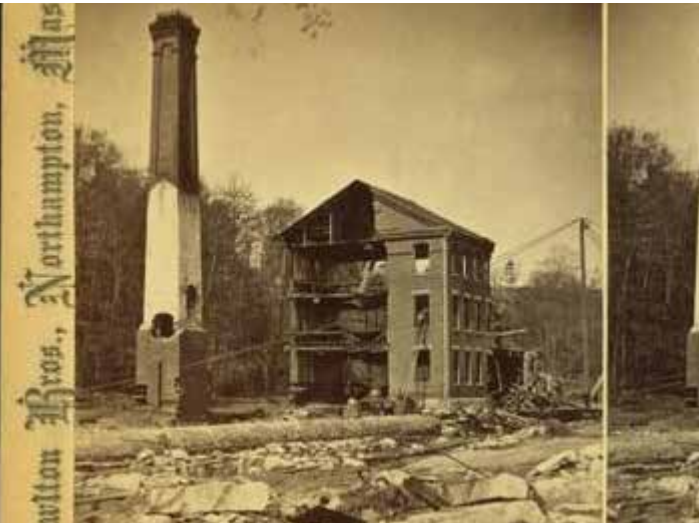
The Brassworks was severely damaged by the 1874 flood. Some of the original foundation still remains. (Source: [digitalcommonwealth.org](http://digitalcommonwealth.org); accessed 8/17/15.)

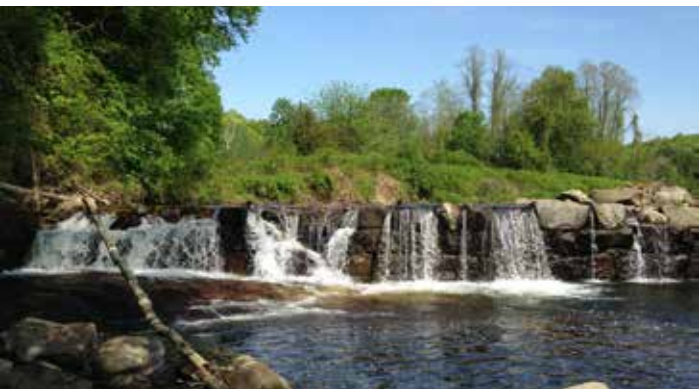
Damaged by storms, the dam is perhaps half its original height, and what remains of the former pond is filled with sediment. Much of the original pond area is growing in with vegetation.

- The Brassworks dam is only a few feet high (reflecting damage from Hurricane Irene in 2011) and the lower water levels have greatly reduced the size of the former Millpond.

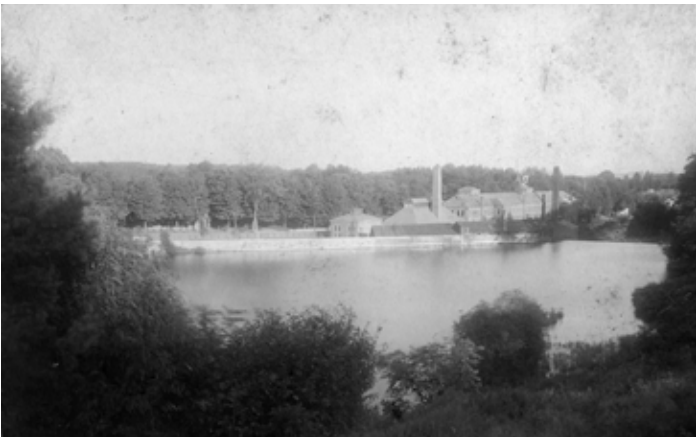
**1910:**  
*The mill pond extended northwest from the Brassworks. This photo shows the extent of the pond reaching even further perhaps than the historic 1873 map (lower left corner).*

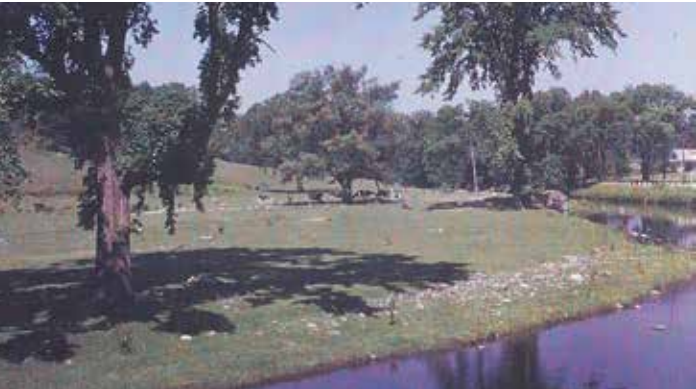
**1940-1965:** *This photo shows the foundation of a bridge that once connected Route 9 to the west side of the river. The photo shows the land being used as a cow pasture, with scattered Elm trees, now deceased.*

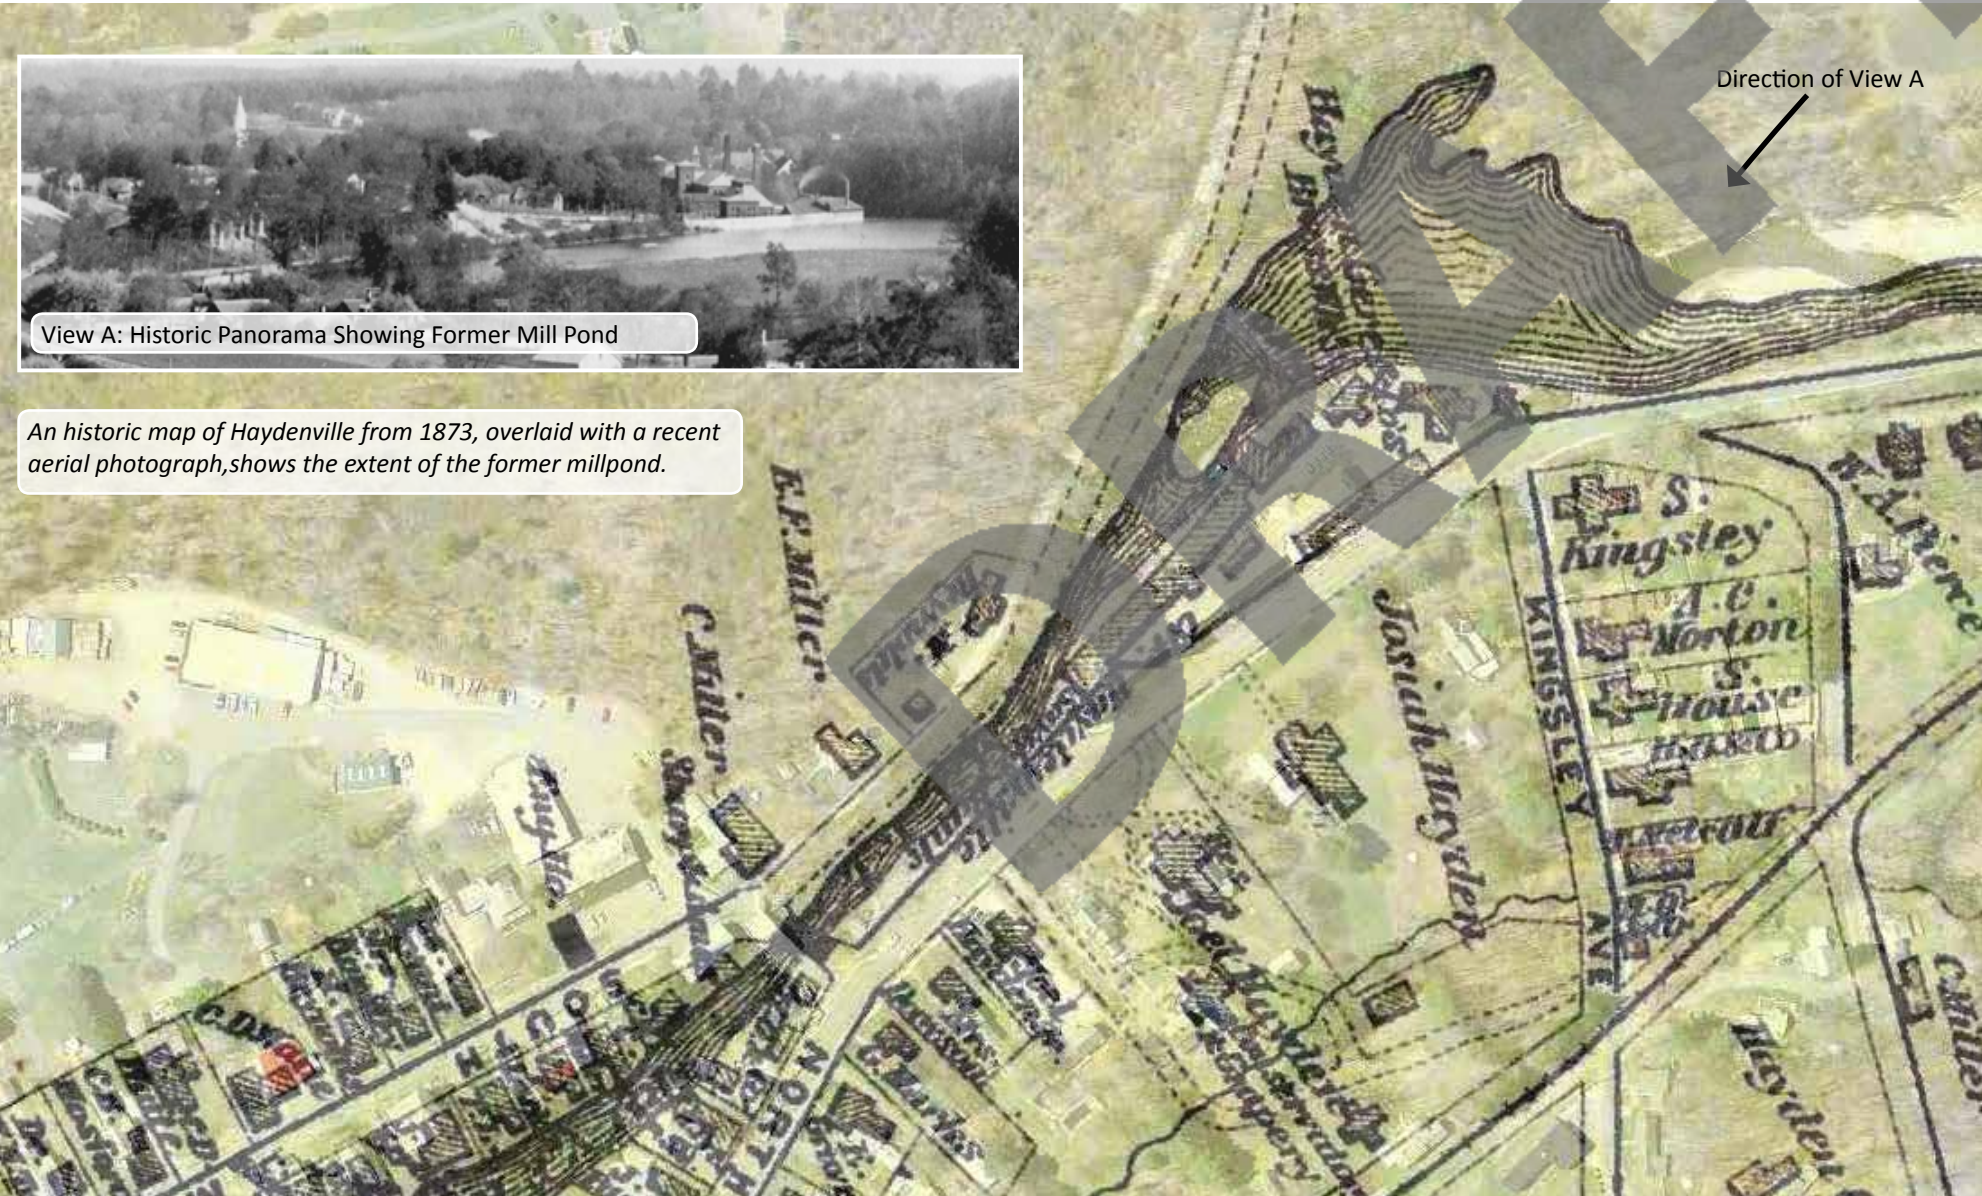
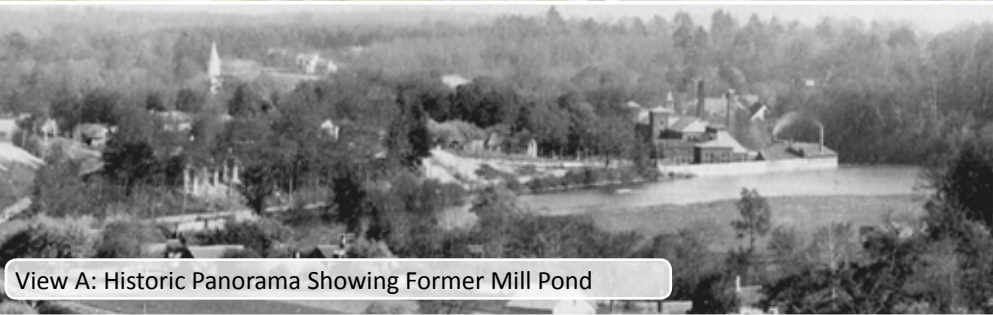
View A: Historic Panorama Showing Former Mill Pond

An historic map of Haydenville from 1873, overlaid with a recent aerial photograph, shows the extent of the former millpond.

had supported a large millpond in the river's flood plain (see sheet 5 for map of former millpond). The dam was rebuilt with the mill, but began to decay after the Brassworks closed in 1954. By 1970, the flashboards holding the water level 2-4' higher had disintegrated. Today, the river cuts its way through the remains of the dam and the pond is much reduced in size. While further damaged in Hurricane Irene, the dam continues to impact the ecology of the river and is the site of ice jams during the spring thaw.

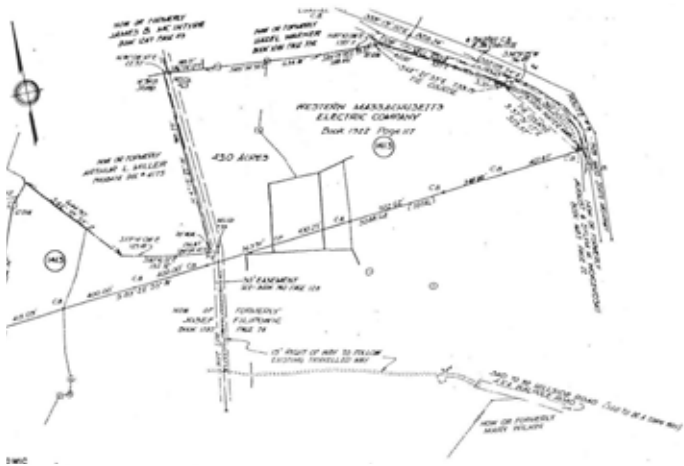
**1976:**  
The parcel that Eversource Energy (a public utility company) owns is not currently being utilized. Eversource may be willing to sell the parcel.

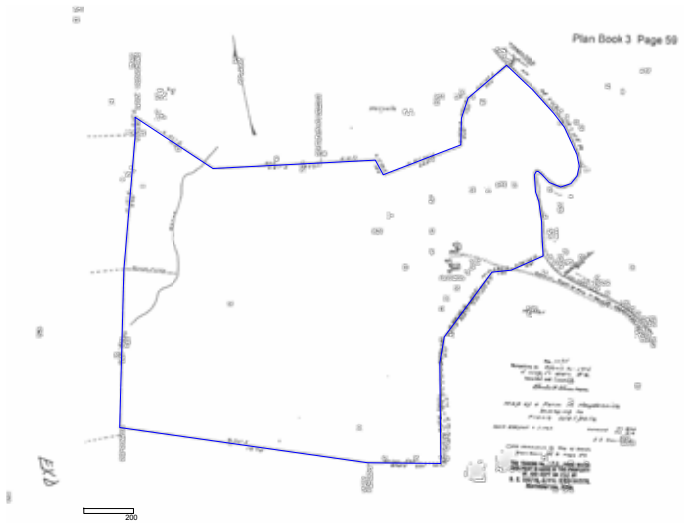
**1916:**  
The parcel map for what is now Valley View Farm does not align well with either the 1976 survey nor the town’s current GIS level 3 assessor’s maps (see overlays, opposite). However its northern edge does seem to align with the field edge and stone walls visible on the aerial photo.

- The Town Assessor’s map from GIS aligns more accurately with the 1976 survey than it does with the 1916 survey, although it still does not align perfectly.
- The river appears to have served as a property boundary for the 1916 Valley View Farm survey, and has apparently shifted in its course over time.

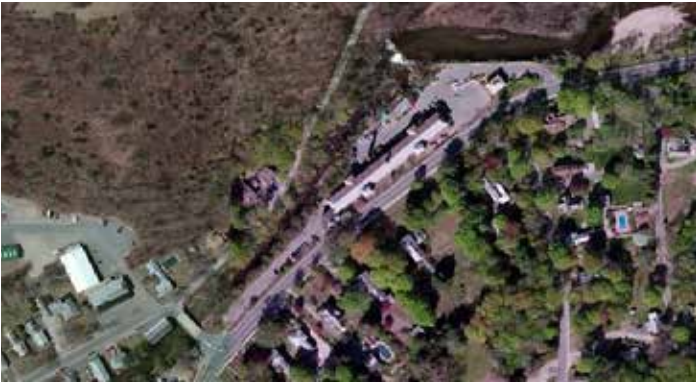
The number of the Brassworks parking spaces (90) was estimated using orthophotography. The Town Building inspector should be consulted to more accurately determine parking code requirements.

- The Brassworks is 58,001 square feet with roughly 90 parking spaces.
- To meet the requirements of the zoning bylaw the Brassworks needs 232 parking spots, but it is 142 parking spaces short.
- A small part of the Valley View Farm is zoned as Village Residential and the rest is zoned as Rural Residential.
- The number of people traveling up Walpole Road to Valley View Farm to visit the farm stand and other uses has grown and will likely increase in the future.
- Route 9 is a busy road (11,879 Average Daily Trips (ADT) moving 30-40 mph) with narrow shoulders and short sight lines due to curves.

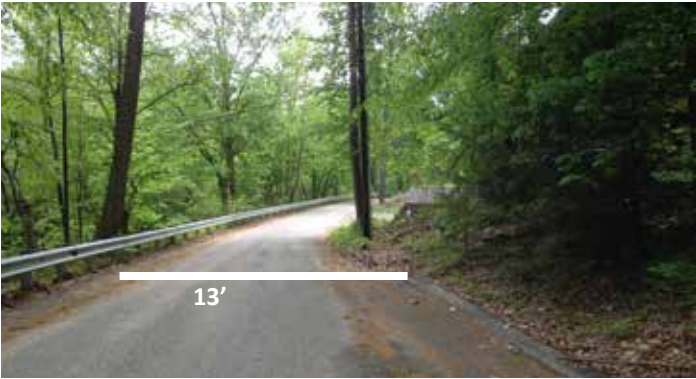
Walpole road is the only public access to Valley View Farm. The potential for widening the road is limited due to the steepness of the adjoining slopes.

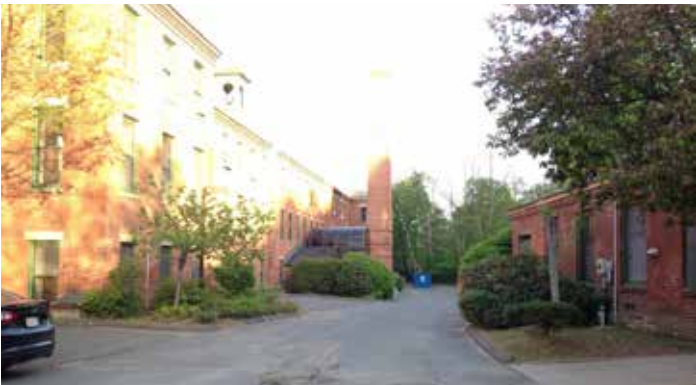
There is little additional land on the Brassworks property to expand parking. Addition of a shared-use path could reduce the amount of available parking.

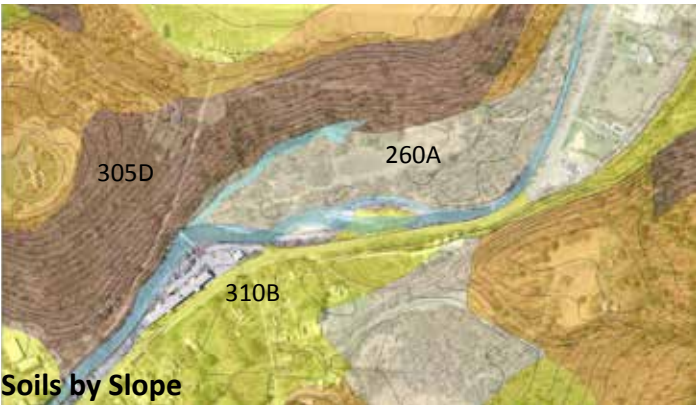
*This soils by slopes map shows fine sandy loam on steep slopes on the west side of the Mill River which are prone to high runoff and erosion. To the south, similar soil (Paxton Fine Sandy Loam) on more moderate slopes is rated very differently.*

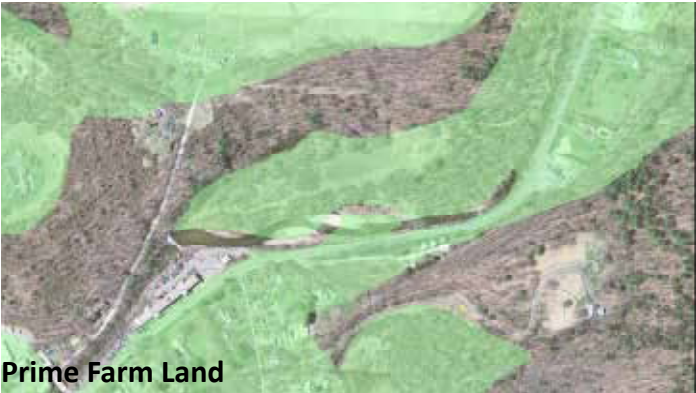
*Fine sandy loam in flat areas can be ideal conditions for farming. The band on the west side of the river shows where slopes are too steep for farming, despite similar soil quality.*

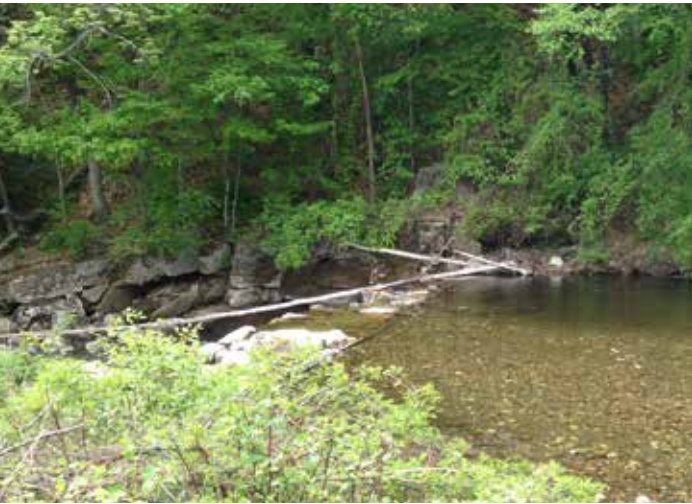
The area west of the dam is characterized by steep, forested slopes, most of which are above 30% and plunge abruptly to the edge of the river.

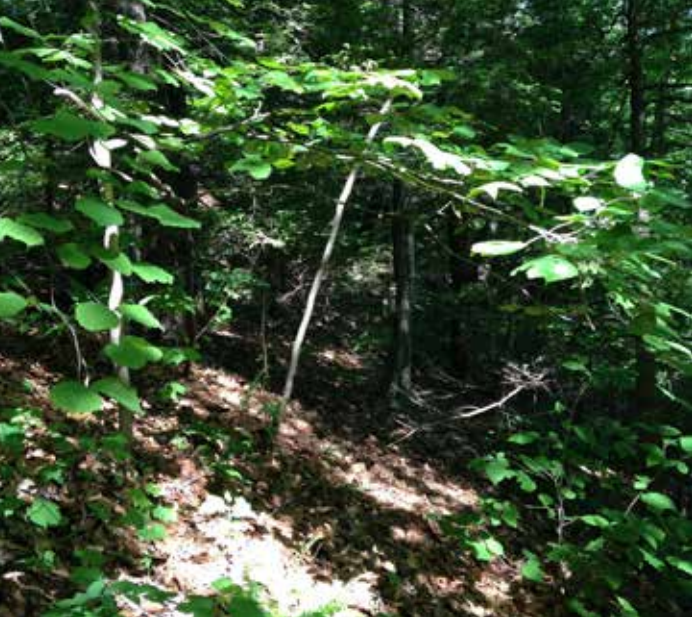
Left: The slope on the west side of the Mill River is densely forested. Significant clearing would have to occur in order to create a shared-use path through this area.

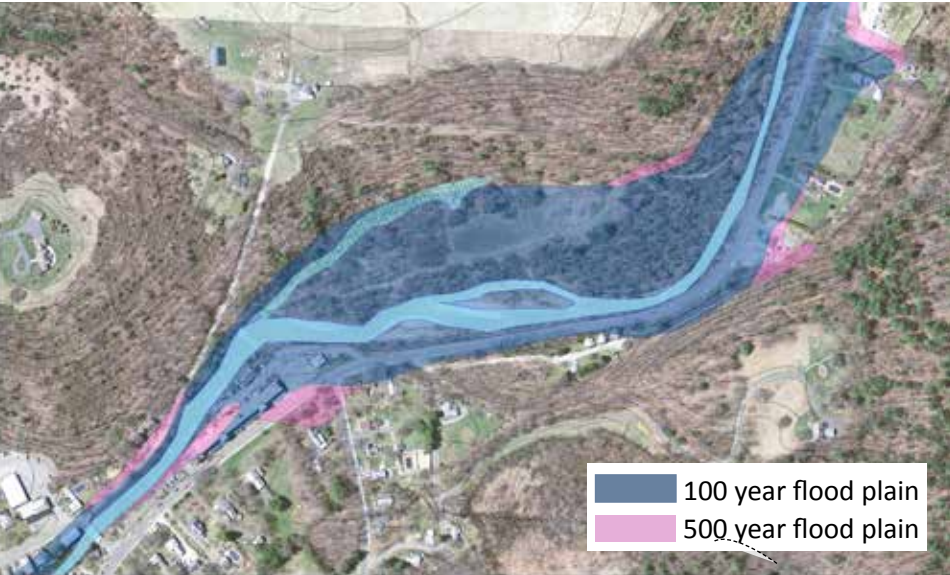
Below: The 100-year flood plain is constrained by the surrounding slopes, with narrow areas of transition that make up the 500-year flood plain.

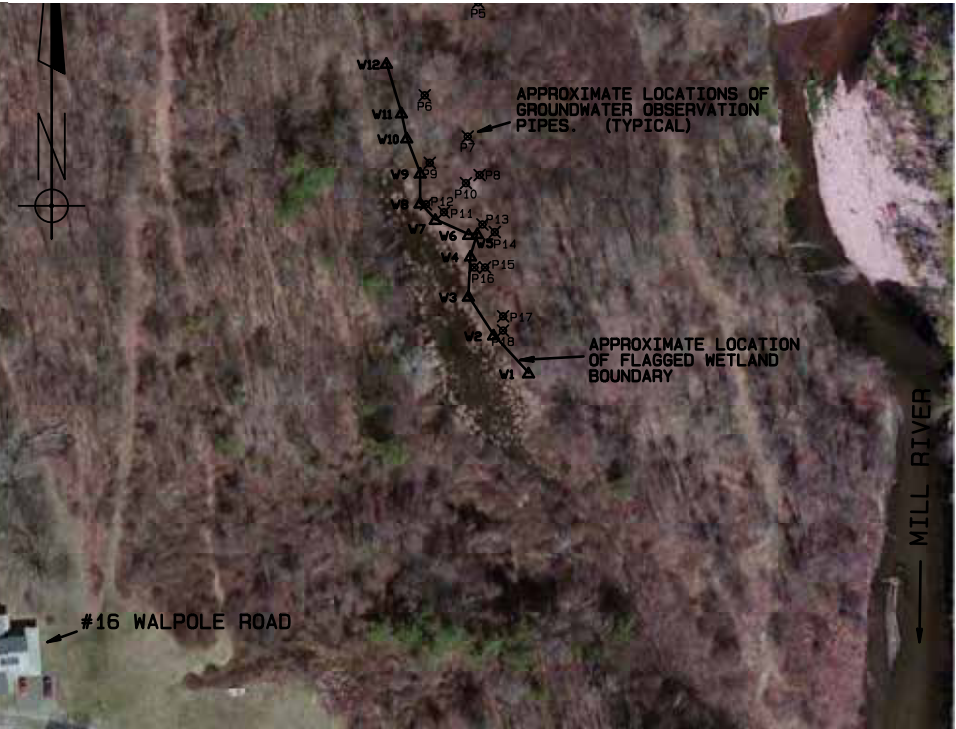
PLAN OF  
WETLAND DELINEATION NEAR  
RECENTLY DISTURBED AREA  
16 WALPOLE ROAD  
HAYDENVILLE, MA

WETLAND BOUNDARY AND GROUNDWATER OBSERVATION PIPE LOCATIONS SHOWN ON PLAN ARE APPROXIMATE ONLY, INTENDED TO FACILITATE ON-THE-GROUND REVIEW AND FOR GENERAL REFERENCE. LOCATIONS BY GPS WITH TYPICAL 2 METER OR BETTER ACCURACY.

NONE OF THE OBSERVATION PIPES SHOWED WETLAND HYDROLOGY DURING THE MONITORING PERIOD, 4/17/14 - 5/10/14. DOMINANT SPECIES IN DISTURBED AREA APPEARS TO HAVE BEEN MULTIFLORA ROSE (*Rosa Multiflora*).

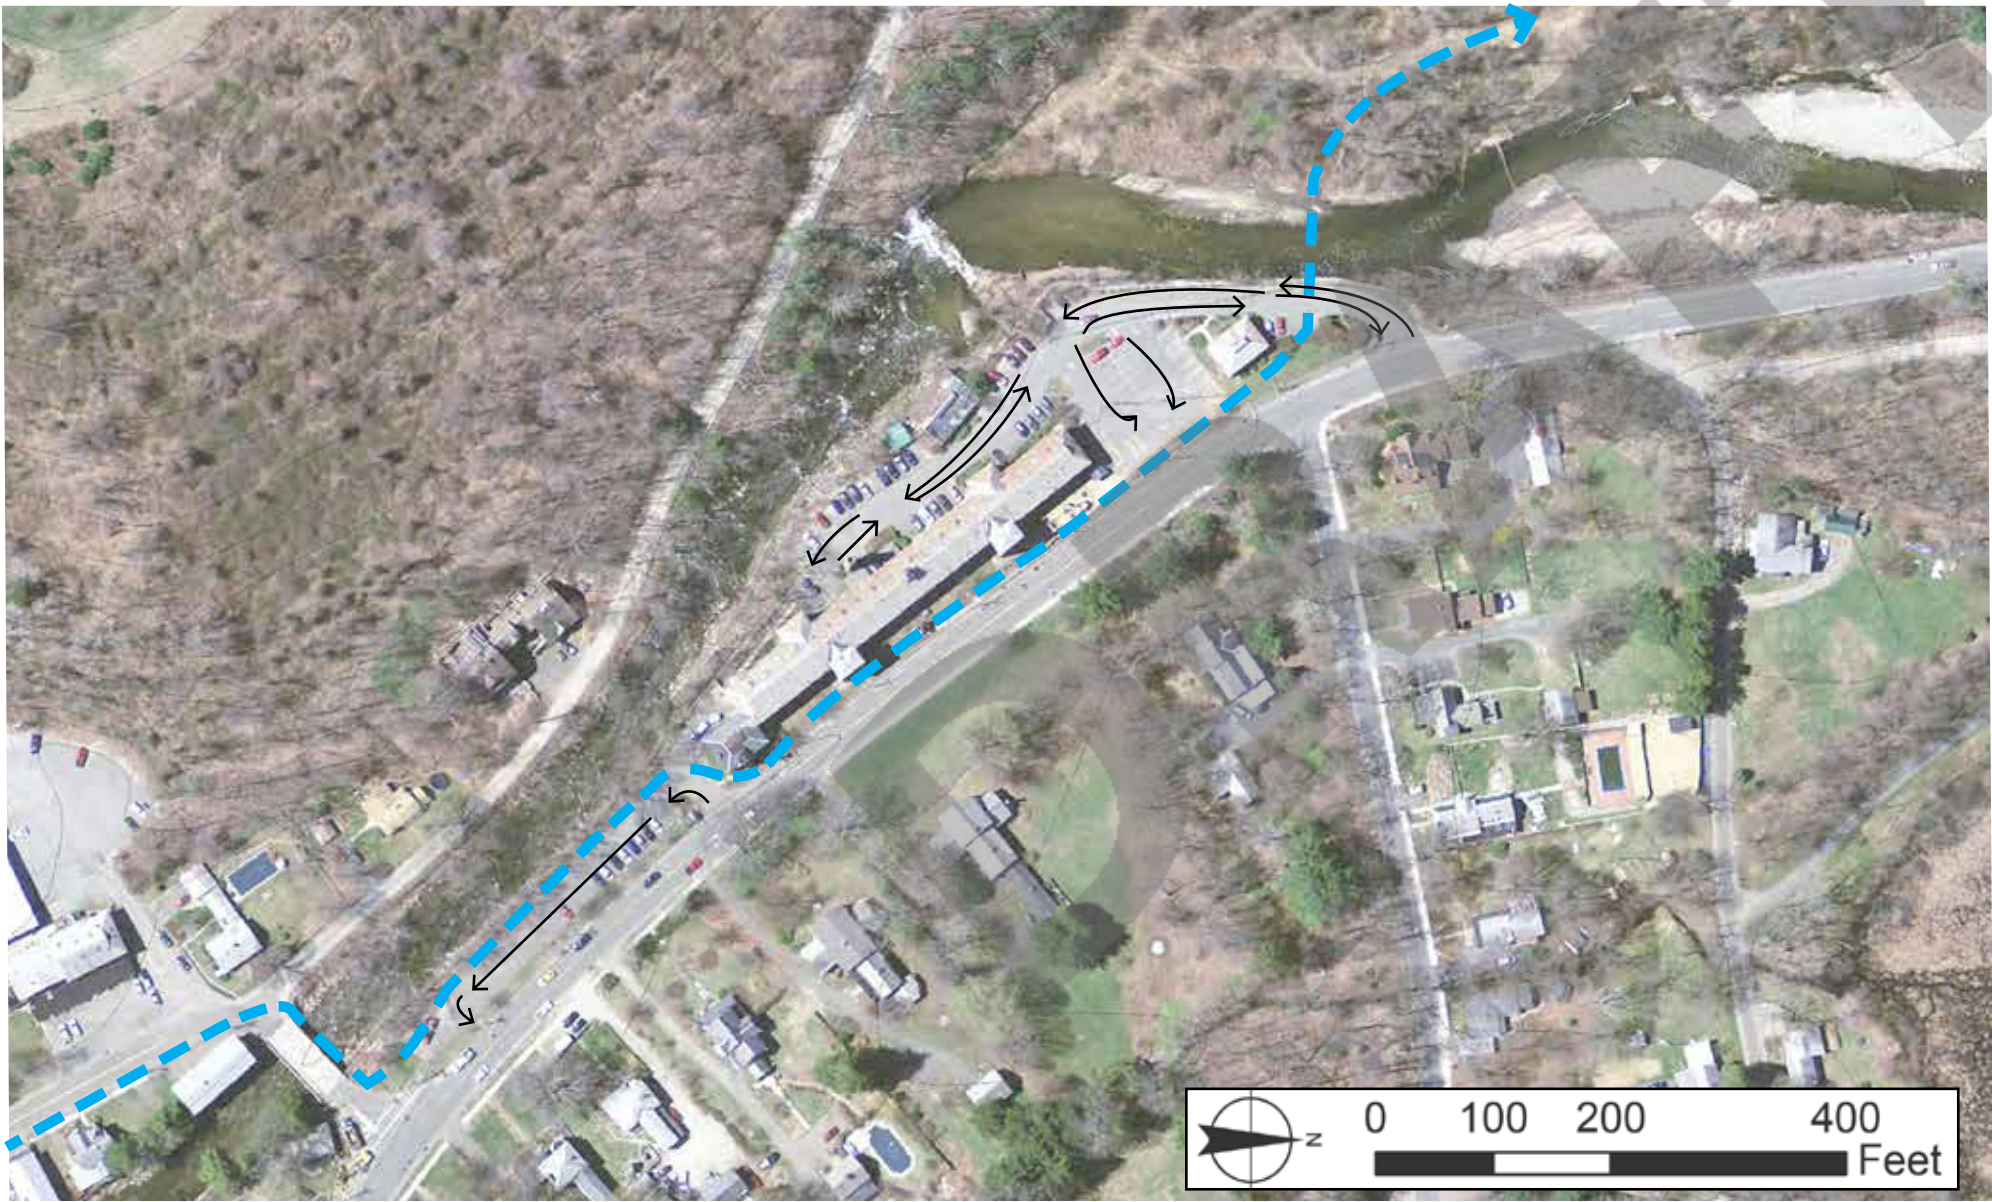
# Alternative 1: Along Route 9 - “the Path of Least Resistance”

The path passes between the Brassworks and Route 9, below a retaining wall, with a new bridge crossing the river at the north end of the Brassworks. Vehicular circulation remains the same in the main Brassworks lot and no parking is lost. Parking in the southern lot moves closer to Route 9 and circulation becomes one way.

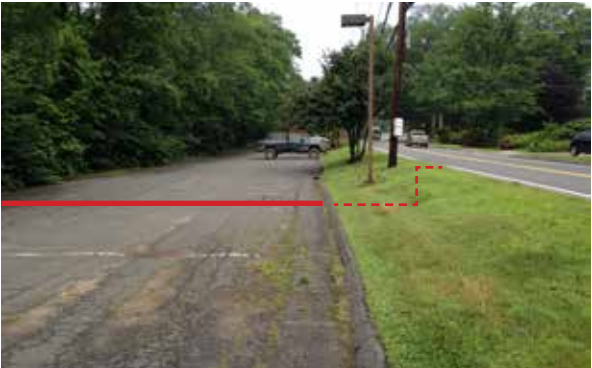
In order to fit a 10’ path and the parking lot together, the width of paving will need to be expanded, which may call for a roughly 2’ retaining wall next to route 9.

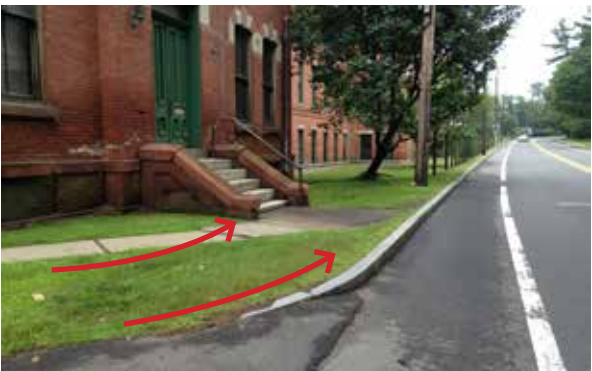
Wrapping a 10’ path around the front of the Brassworks will impinge on the southern end of the building. Here, the stoop will need to be removed or relocated.

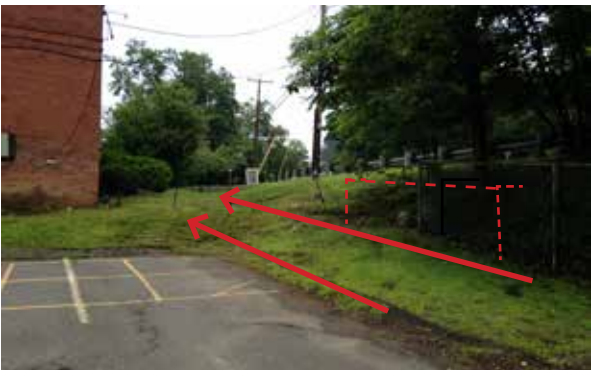
The path will continue around the north-east side of the smaller northern building. This may require the existing retaining wall be extended to the north.

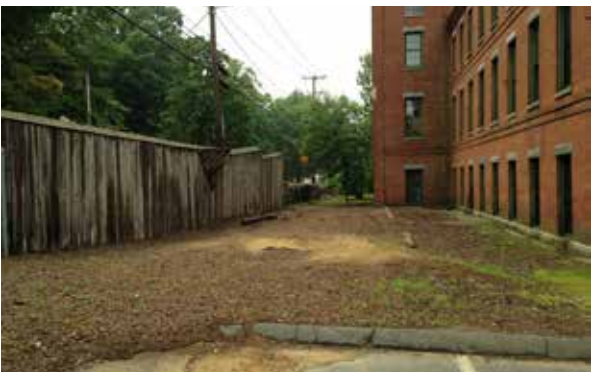
The space between the Brassworks and route 9 is currently underutilized and in need of attention. The path and some adjacent plantings may have the potential make this space more functional and beautiful.

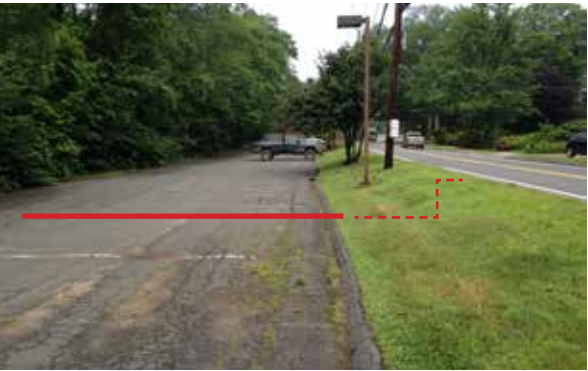
In order to fit a 10' path and the parking lot together, the width of paving will need to be expanded, which may call for a roughly 2' retaining wall next to route 9.

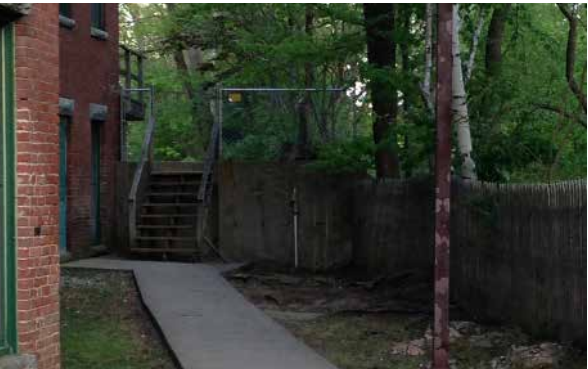
Connecting the path from the southern parking lot to the back parking lot will be challenging because of an existing loading ramp. The ramp will need to be removed and the ground leveled.

- 1. Significant excavation will be required to lower the existing the Brassworks loading dock to ground level.

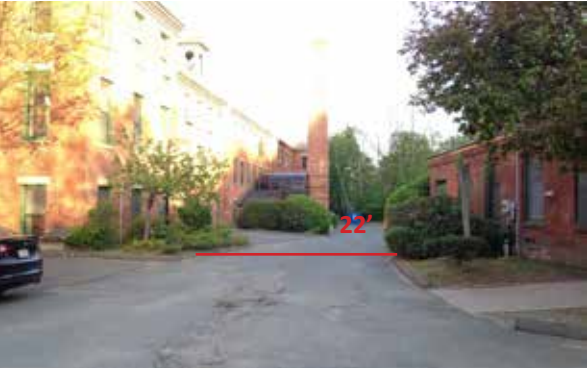
Path users and vehicles would have to share a section of the parking lot, or parking will need to be eliminated.

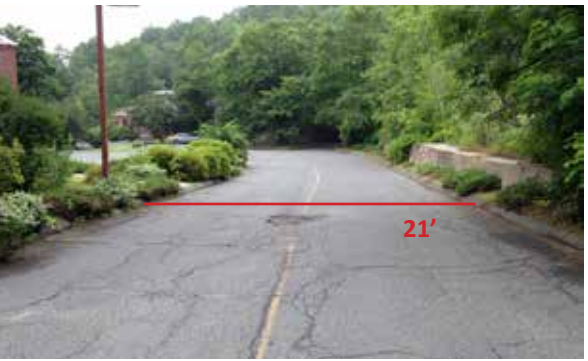
With little room to widen the road, path users and two way vehicular traffic will have to share this portion of the road leading to the Brassworks entrance on route 9.

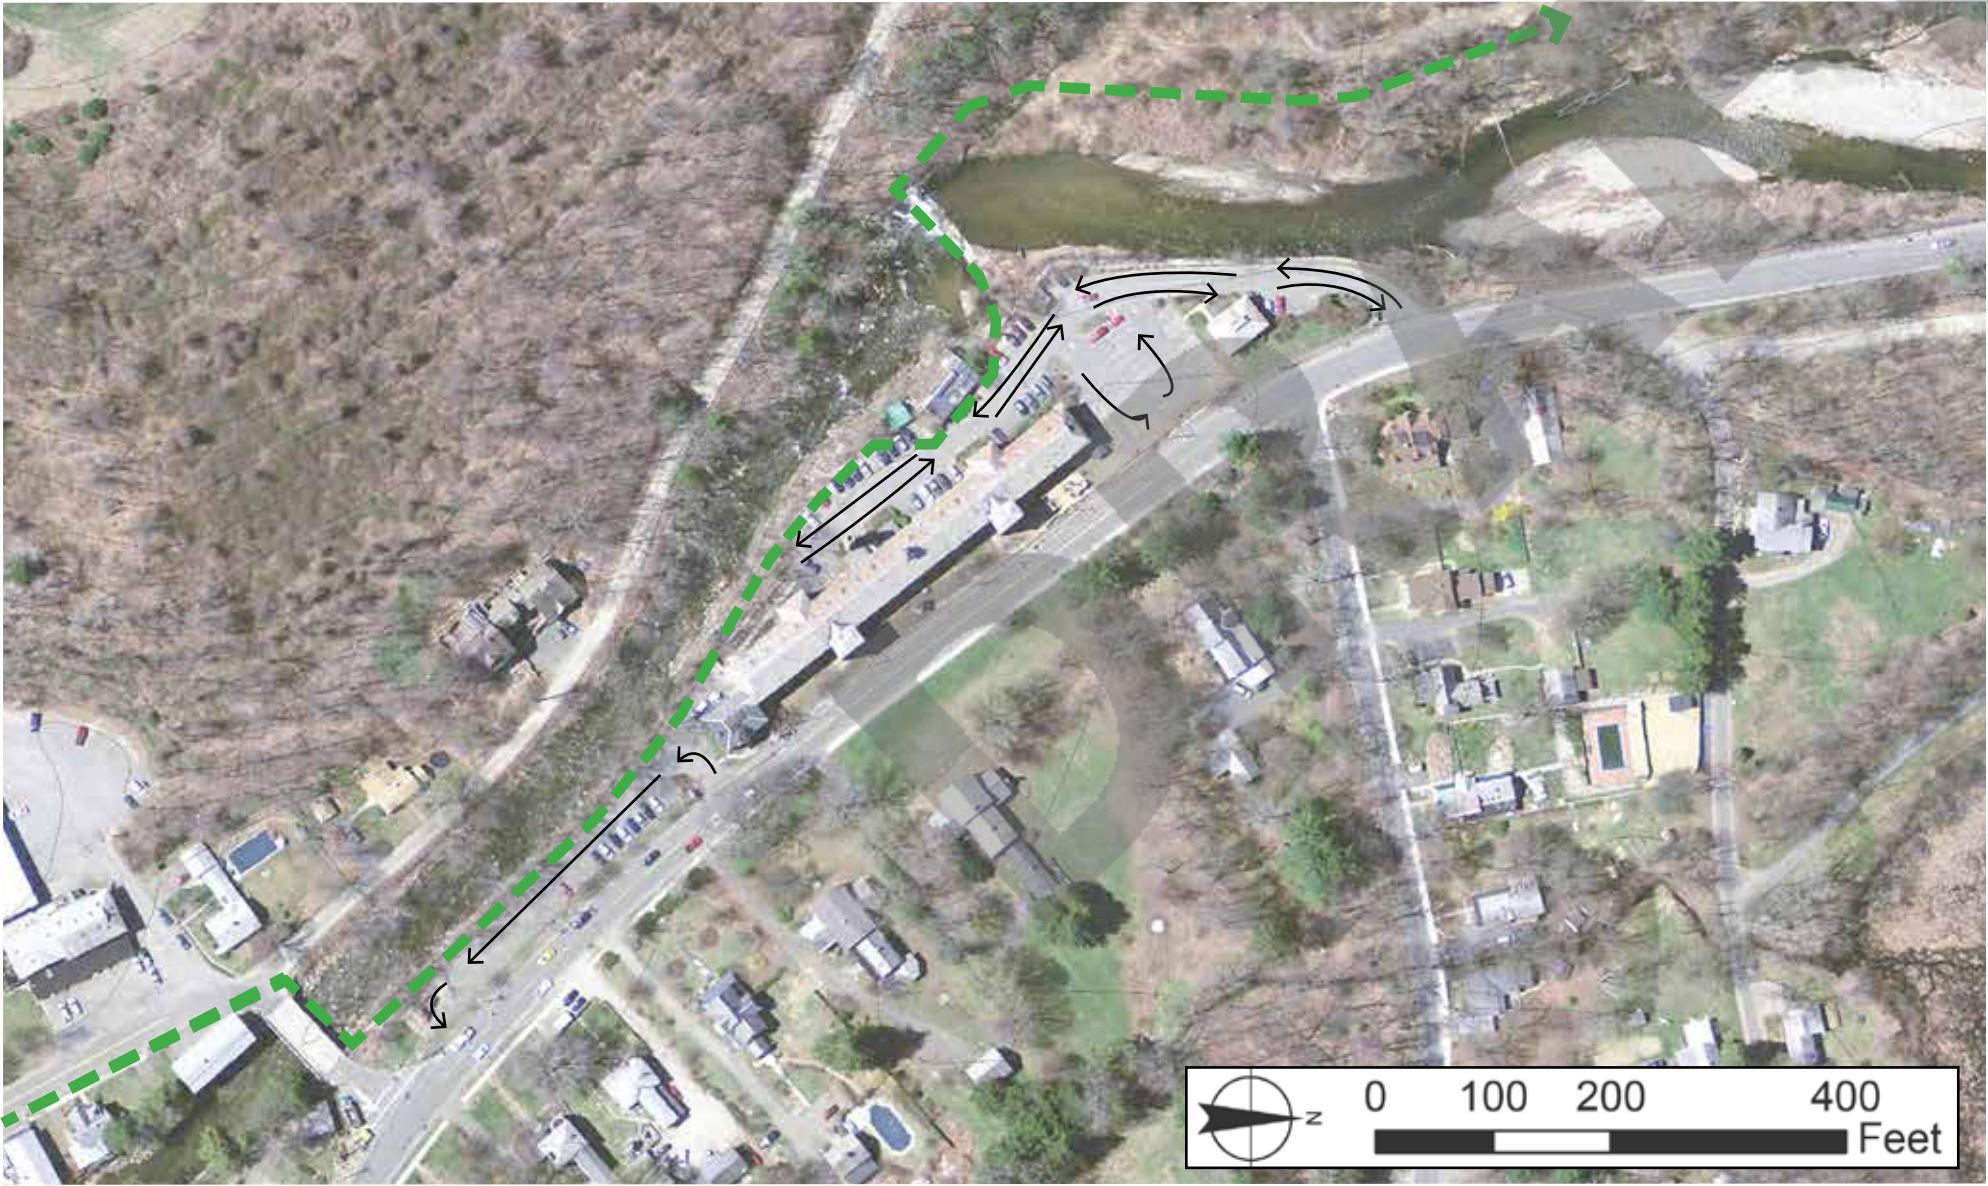
*Vehicular circulation remains the same through the Brassworks parking lot, though some parking spaces along the river on the north side could be compromised by the path. A new bridge uses the foundations of the historic dam. The southern parking lot moves closer to Route 9 and becomes one-way.*

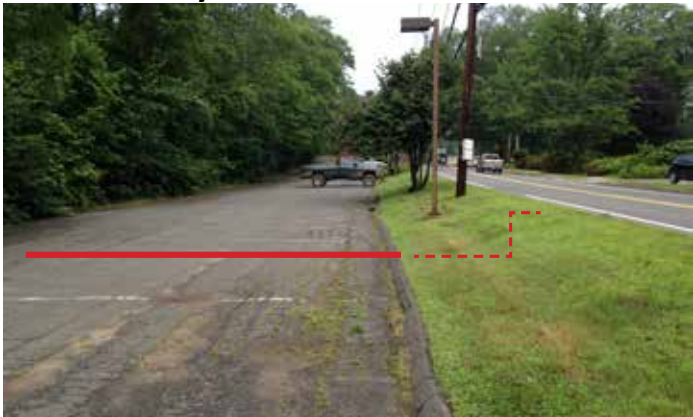
*In order to fit a 10' path and the parking lot together, the width of paving will need to be expanded, which may call for a roughly 2' retaining wall next to route 9.*

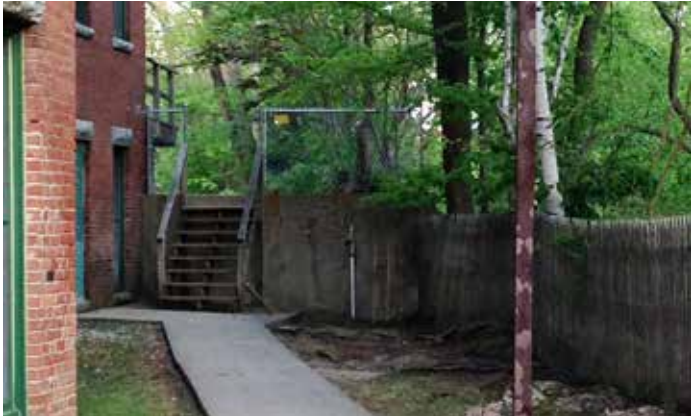
*Connecting the path from the southern parking lot to the back parking lot will be challenging because of an existing loading dock/ramp and stair. The ramp will need to be removed and the ground leveled.*

- 1. Demolition will be required to lower the existing Brassworks loading dock/ ramp to ground level
- 2. The structural integrity of the building could be compromised by the removal of the ramp. Consulting a structural engineer will be necessary.
- 3. The Brassworks parking lots will lose at least 6 parking spots.
- 4. The path will go through a wetland and floodplain, likely requiring replication and compensatory flood storage.
- 5. The path will go through a very steep section of river embankment and forest.
- 6. Cars and trail users will likely have to share a small stretch of the parking lot road.
- 7. Informal use of the swimming hole at the dam could be compromised.

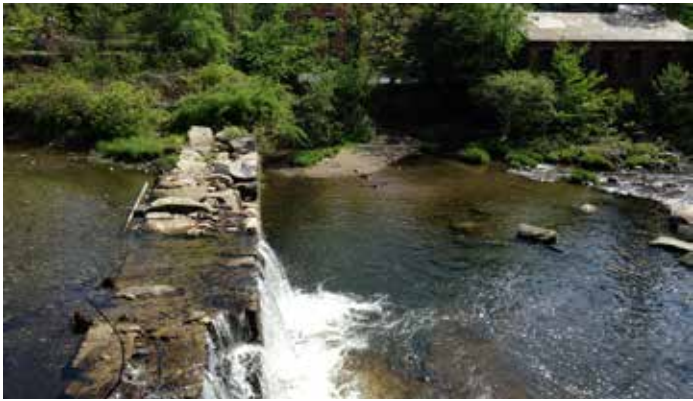
*It may be possible to use the foundation of the existing dam, pending structural investigation, potentially reducing construction costs and impacts.*

- Is the existing historic dam structurally sound enough to use the existing foundation for a new bridge?
- Is it possible to make the southwest parking lot one-way, adding another/entrance exit on the end of the parking lot near the Haydenville library?

- Consult a structural engineer to evaluate the feasibility of re-purposing the existing dam substructure as foundation or footing for the bridge.
- Consult a traffic engineer to identify southwest parking lot constraints and requirements

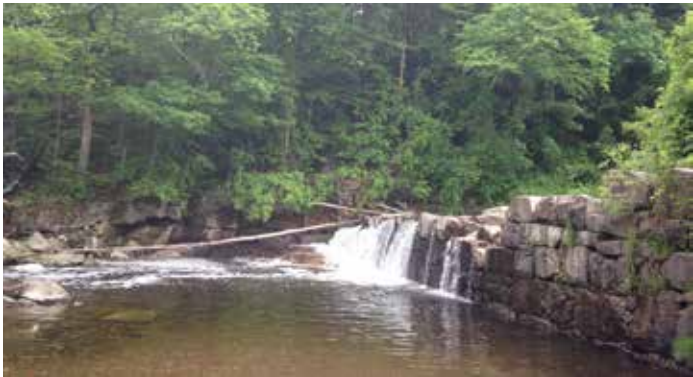
*Path users will get a lovely view of the dam and river, but the bridge itself will change the existing character of the area.*

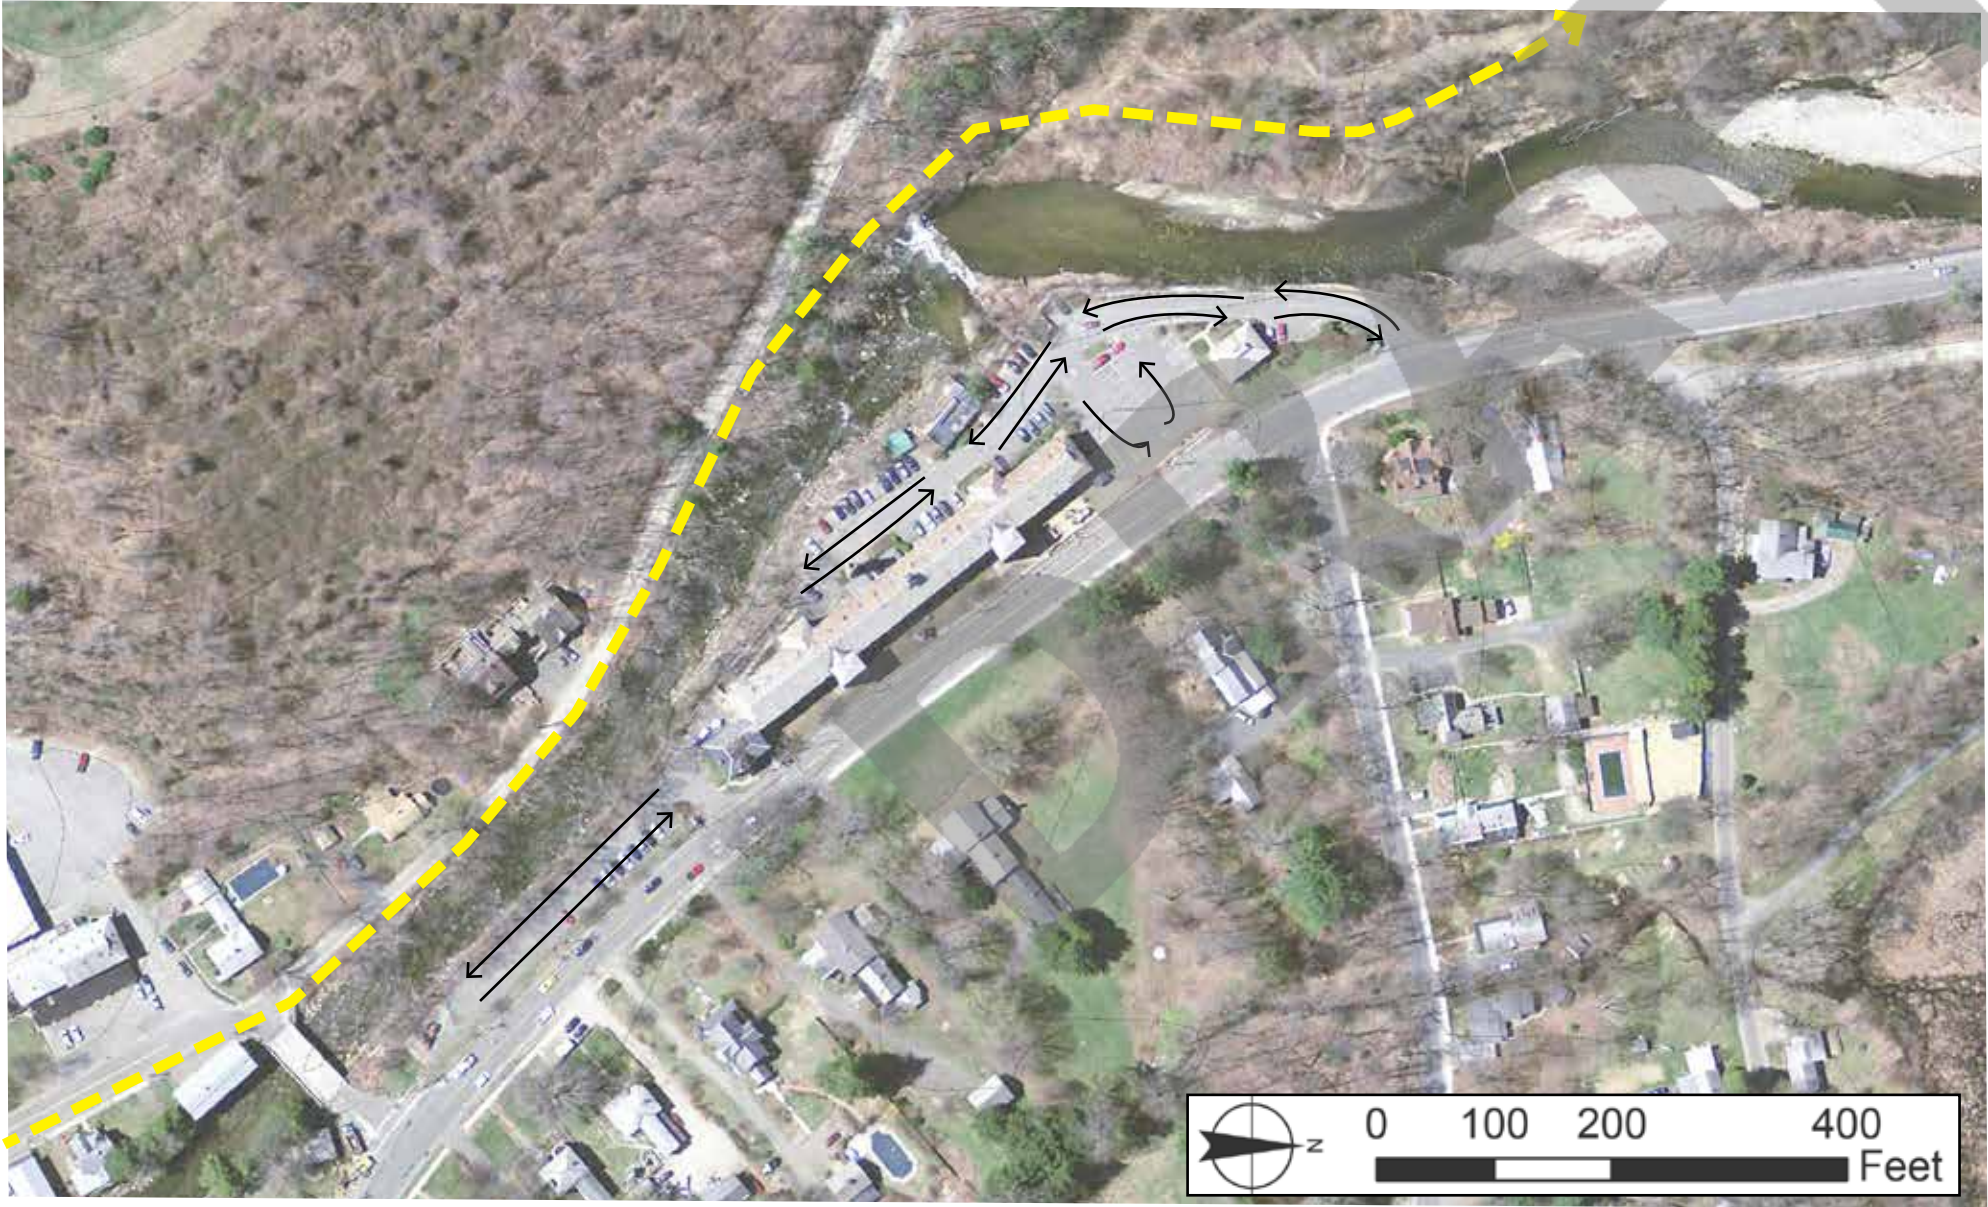
- 1. The path will require cutting a corridor through healthy, mixed upland forest along the very edge of the river.
- 2. Putting the path along a very steep slope could lead to erosion, and a flood could be very destructive to the path.
- 3. Rivers migrate over time; keeping the structural supports of the path intact over time may prove challenging.
- 4. The path will go through a wetland and floodplain. Wetland replication and compensatory flood storage may be required elsewhere on site.
- 5. The retaining walls or cantilevered decks that would likely be needed to construct a path along the steep slope could be prohibitively expensive.

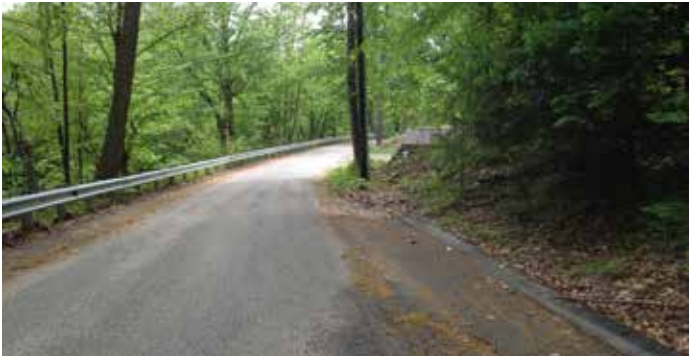
*The path will share part of Walpole Road, which is relatively narrow and steep, before turning off to run along the western bank of the river.*

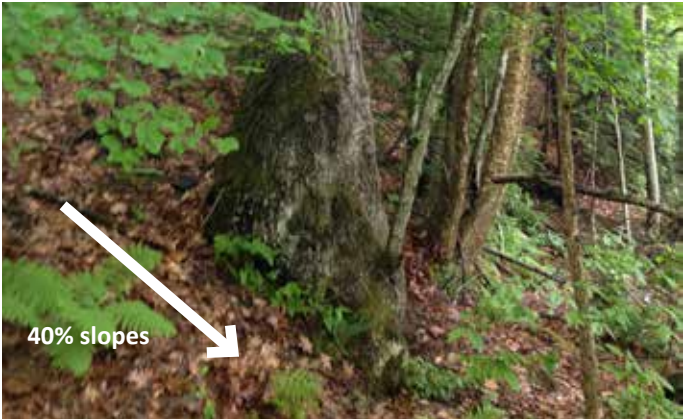
*Slopes in areas are in excess of 40%, probably requiring a boardwalk or viaduct approach rather than filled terrace with retaining walls. There would likely be impacts on many large trees and ongoing issues with drainage and erosion control.*

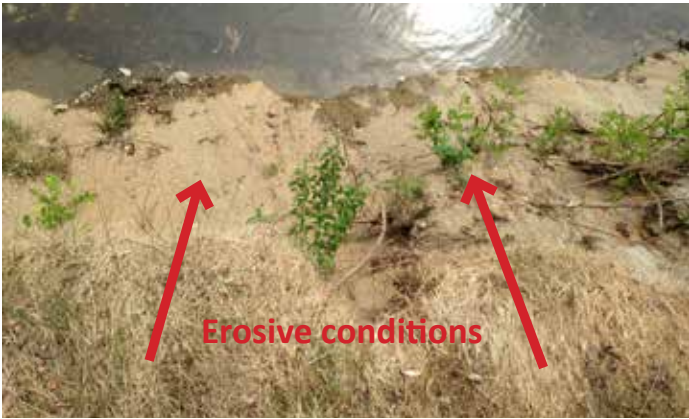
*Lacustrine sediment, due to the presence of the historic Mill Pond, extends along the west side of the river. Construction of the path will require careful analysis and planning for drainage and erosion control.*

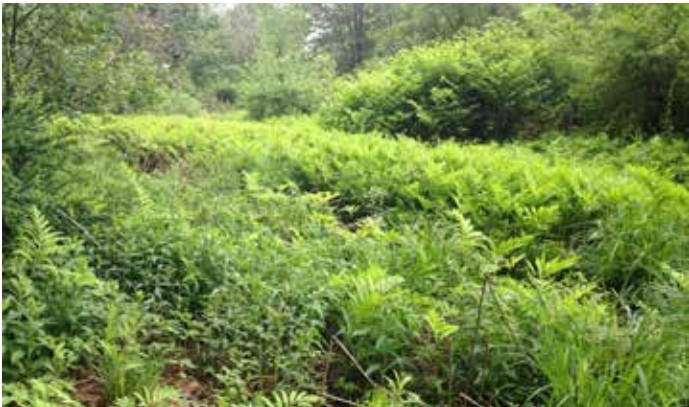
*The path would probably disturb at least 500 square feet of wetlands, which would need to be replicated elsewhere on site. Filling within the floodplain would need to be mitigated with compensatory storage.*
