**Town of Williamsburg
Building Needs Committee**
December 7, 2010

Town of Williamsburg Building Needs Committee:

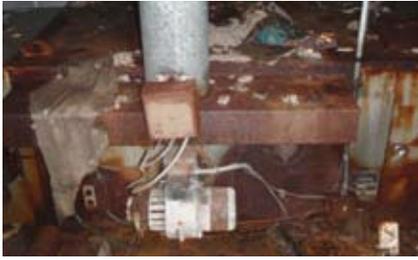
The building is not heated. Its boiler has not been functional for years.

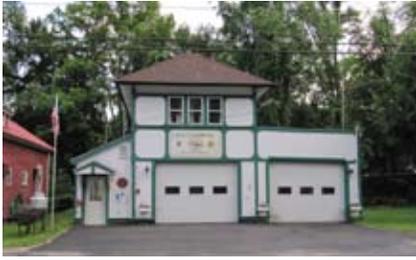
There is no room for firefighters or the public to park on the parcel.

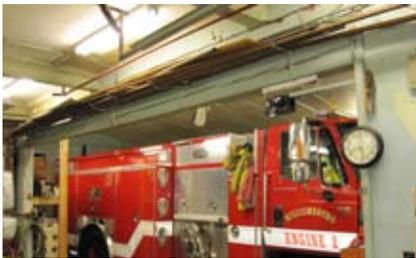
The fire trucks barely fit through the doors and within the length of the bays.

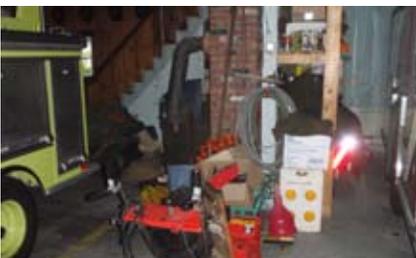
There is insufficient storage space. Floor space is used to store gear.

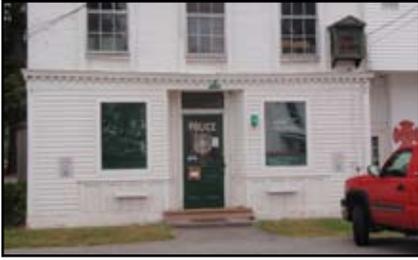
There is minimal parking for the public and for police vehicles.

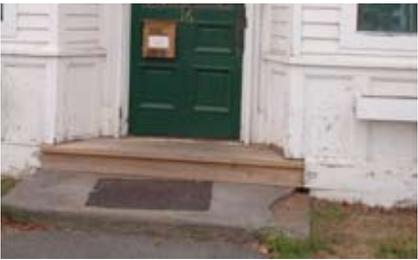
Most areas of the police station are not handicapped accessible.

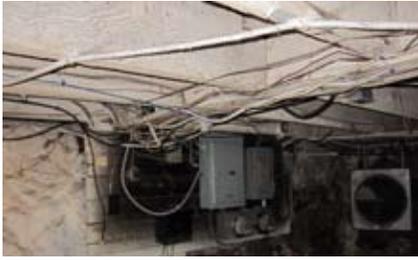
Wiring is outdated and much-modified.

Boiler and water heater are old, in poor condition. Cooling is by open window. Electrical service is adequate for the minimal draw. All wiring is old and much-modified, mostly out of code compliance. Plumbing is minimal, leaky and outdated. There is a public sewer connection. There are no sprinklers. There is no fire alarm system or security system. Heating uses about 1,000 gals of fuel oil per year with thermostat set in mid-forties.

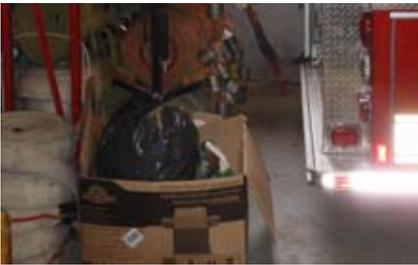
The department uses valuable floor space for storage of fire gear due to lack of other storage space.
